Life Test of 76-Ah Nickel-Hydrogen Cell Designs after 14 Years of Storage

10 January 2010

Albert H. Zimmerman and Michael V. Quinzio
Electronics and Photonics Laboratory
Physical Sciences Laboratories

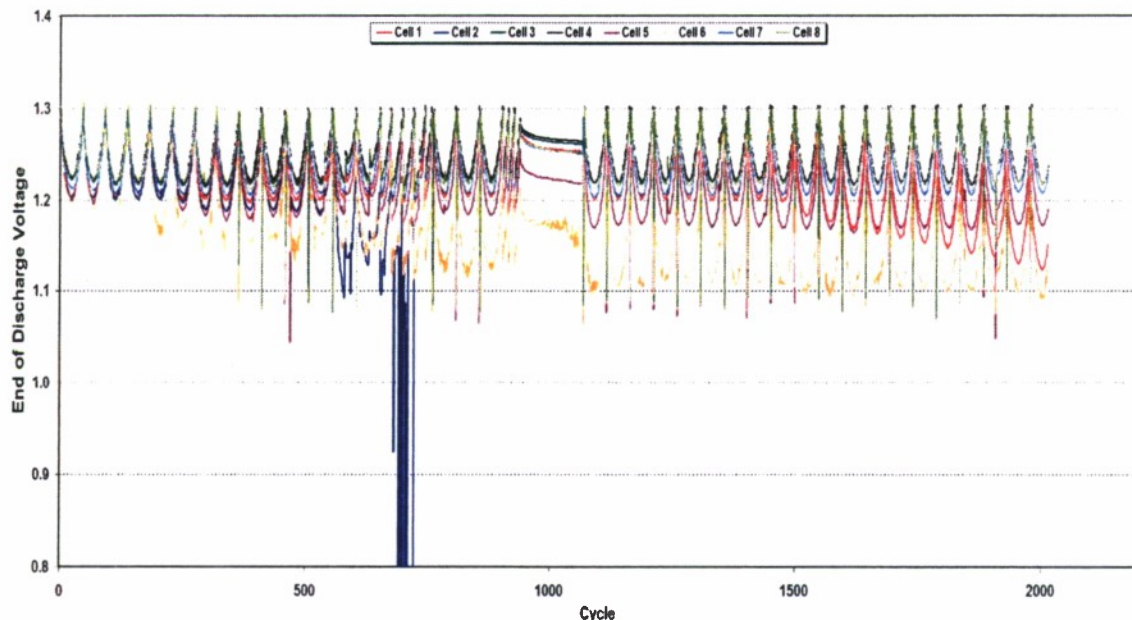
This life test has completed 44 of the 45-day cycling sequences, amounting to 2020 total cycles over the approximately 6 years that it has been operating. The minimum voltage during each cycle (excluding the reconditioning and capacity check cycles after each sequence) are shown in Figure 1. As indicated in Figure 1, there have been several periods during the test where programming errors resulted in a few abbreviated or extended cycling sequences. The voltage of cell 5 appeared to be affected by a series resistance arising from the terminal connections that was estimated to be 4.43 m Ω . This has been constant at all times throughout this test for cell 5. The end of discharge voltage for cell 5 in Figure 1 has been corrected for this added resistance.

Inspection of Figure 1 shows that cell 2 developed some performance problems after about 700 cycles. This cell was declared as failed and removed from the test after 742 cycles, with the failure being caused by intermittent short circuit. Within the first 500 to 1000 cycles, cell 6 also developed a low end-of-discharge voltage from elevated internal impedance, although to date, cell 6 has not failed. After cycle 2020, cell 1 failed due to an internal short circuit, and was also removed from the test. Figure 1 shows cell 1 discharge voltage dropping for 400–500 cycles prior to its failure.

Figure 1. End of discharge voltage for each cell during cycling sequences completed.

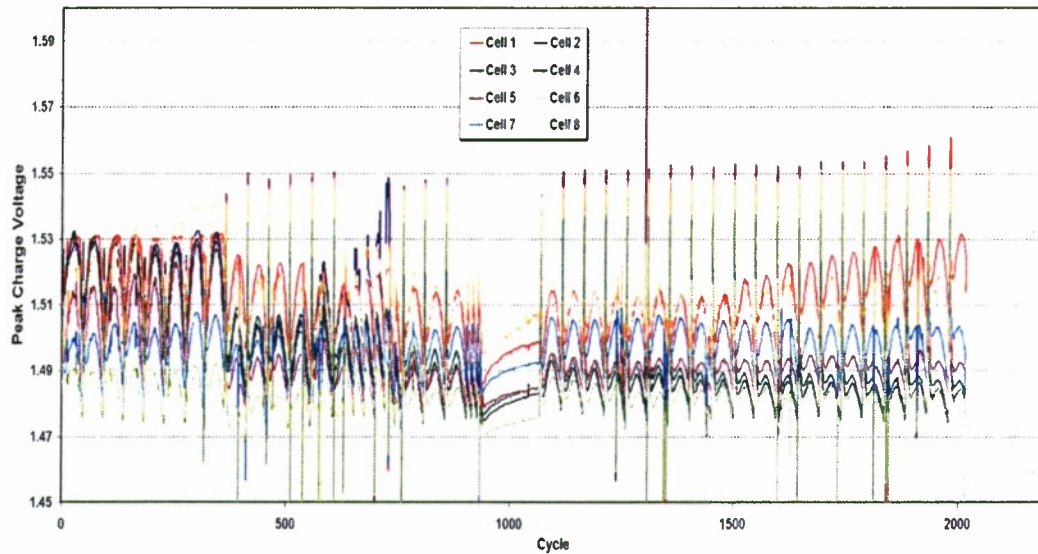
Figure 2 shows the peak recharge voltages during the cycling, which typically occurs at the end of the 6.5 A recharge when the 1.10 recharge ratio has been reached. All cells have remained in the range of about 1.48 to 1.53 V during the test. Elevated peak recharge voltages are seen just prior to the

Figure 2. Peak recharge voltage for each cell during cycling sequences completed.

failure of cell 2 near 700 cycles, and then again for cell 1 near cycle 2000. The voltage spikes that periodically occur up to about 1.55 V are caused by the capacity check recharge done between each 45-day cycling sequence.

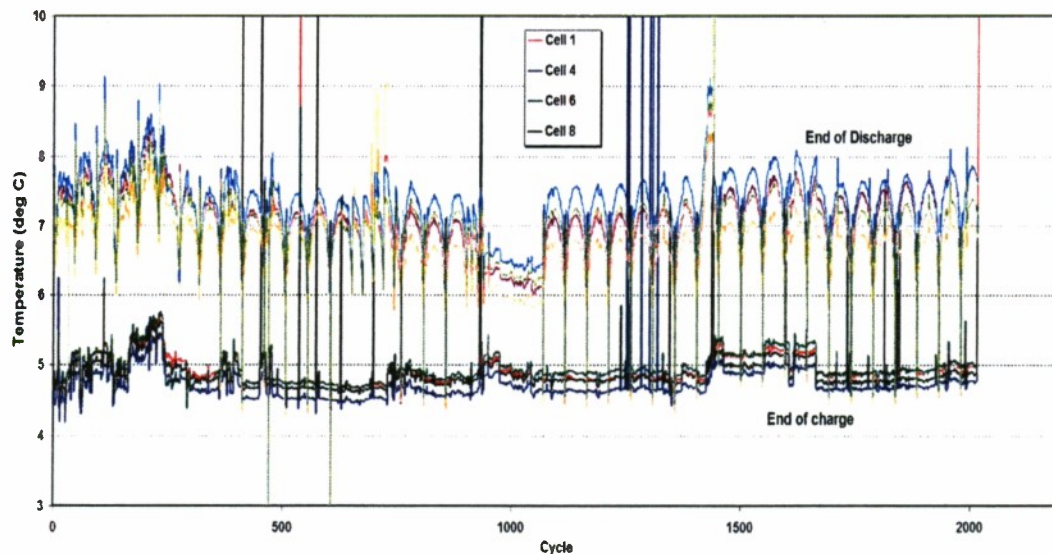
The test temperatures are shown in Figure 3. The significant temperature spikes occasionally seen above 9°C or below 3°C correspond to test problems that upset the chiller thermal control. Such events included power interruptions, bad data readings, and chiller malfunctions. The test temperature has been controlled such that the end-of-charge temperature was held at about 5°C. Discharge heating has resulted in a 2–3°C warming of cells at the end of discharge relative to end of charge.

Figure 3. End of discharge and end of recharge temperatures for instrumented cells during cycling sequences completed. The test is being controlled to about a 5°C end of charge temperature.

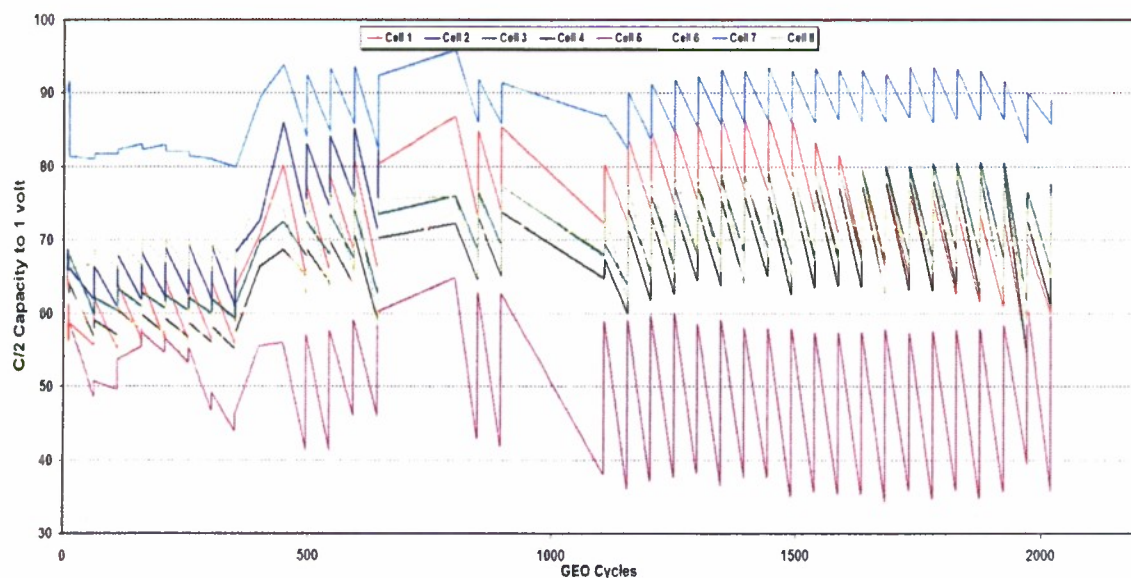
After each 45-day cycling sequence, a capacity discharge is performed from the state of charge that the cells had at the end of the sequence, followed by a second capacity discharge after reconditioning. The cell capacities measured by these capacity checks after each sequence are plotted in Figure 4. The saw-tooth appearance of Figure 4 results from the first capacity measurement, which is directly from the cycling state of charge, always being lower than the second capacity, which is following reconditioning and a full recharge. The lower reconditioned capacity for the first 400 cycles results from the cells only being charged for 12 h following reconditioning, vs. 16 h later in the test. The capacities of all these cells have been relatively stable, with the notable exception of cell 1, which dropped about 15 Ah during the 500 cycles prior to its failure after cycle 2020. Cell 2 showed no significant capacity drop prior to its failure around cycle 700. The main reason for the anomalously low capacity for cell 5 is the extra resistance in the cell circuit, which is believed to be a test artifact since it has not varied with time, cell state of charge, or any other cell-related variable.

Figure 4. Capacity measurements after each cycling sequence. The lower one is directly from cycling, and the higher one is after reconditioning.

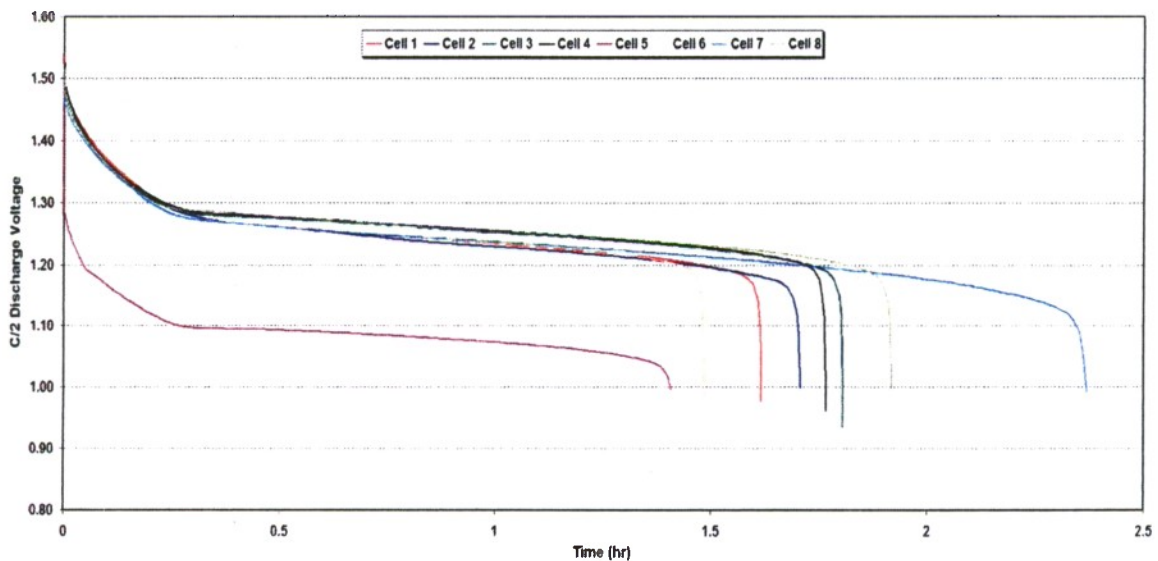
The charge and discharge voltage profiles and how they change during the testing can reveal much about what is occurring in a cell as it degrades. Figures 5 and 6 show the beginning of life discharge and recharge voltages for the cells. Figure 5 shows that the discharge voltage plateaus were similar for all the cells, except cell 5, which had an anomalous resistance in the cell connection wiring. However, all the cells except cell 7 displayed significant capacity loss relative to 76 Ah. These capacity losses range from less than 5% for cell 8 to about 25% for cells 5 and 6. It is believed that these capacity losses resulted from the 14 years of storage (over 15 years from cell activation). The cells with the greater amount of capacity losses tended to be the ones with hydrogen precharge, which is likely to be a contributing factor. It is not clear why cell 7 maintained much better capacity than all the other cells.

Figure 5. Discharge voltage profiles at beginning of life with a C/2 discharge rate.

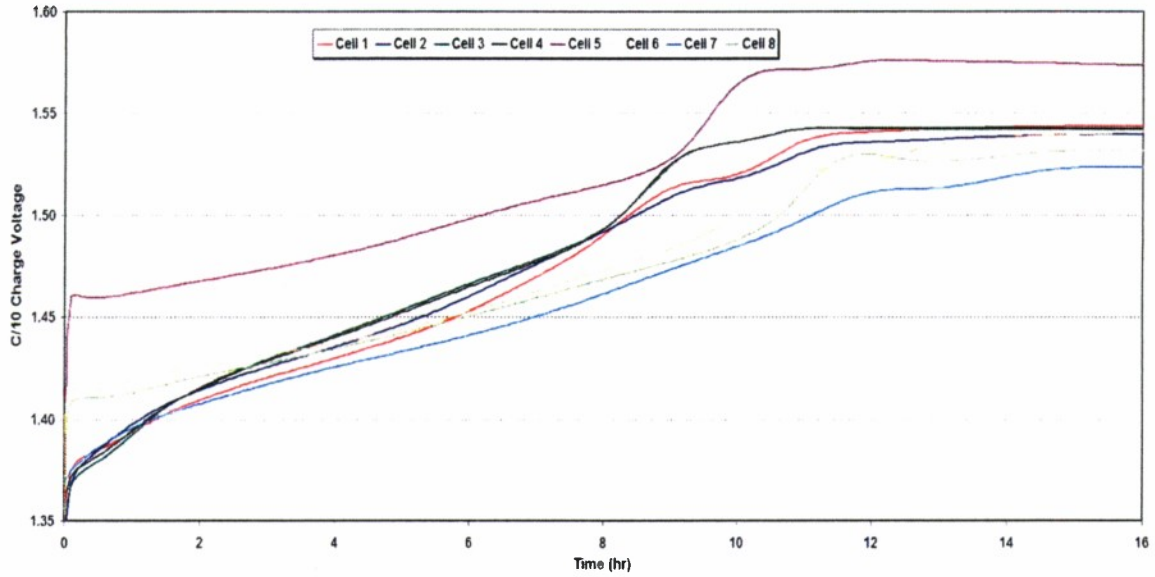
The recharge voltage profiles in Figure 6 clearly show that three of the cells had a hydrogen precharge at BOL (cells 5, 6, and 8), while the other cells had nickel precharge. This is recognized by the sharply increased voltage at the start of recharge, which is caused by a fully depleted nickel electrode. It is not clear why cell 2, which should have contained hydrogen precharge according to the test cell matrix of Table 1, showed nickel precharge here. This observation suggests there are factors that can affect the precharge settings enough to completely lose one atm of hydrogen precharge (one atm corresponds to only about 1.5% hydrogen precharge in this cell design).

The recharge profiles in Figure 6 also indicate which cells had the higher electrolyte concentration. The higher concentration stabilizes the formation of γ -NiOOH during overcharge, thus causing the charge voltage to peak, and then continue rising significantly as γ -NiOOH continues to be generated.

Figure 6. Recharge voltage profiles at beginning of life with a C/10 charge rate.

This is the profile seen for cells 1, 2, 6, and 7, which all contain the higher electrolyte concentration, as indicated in Table 1.

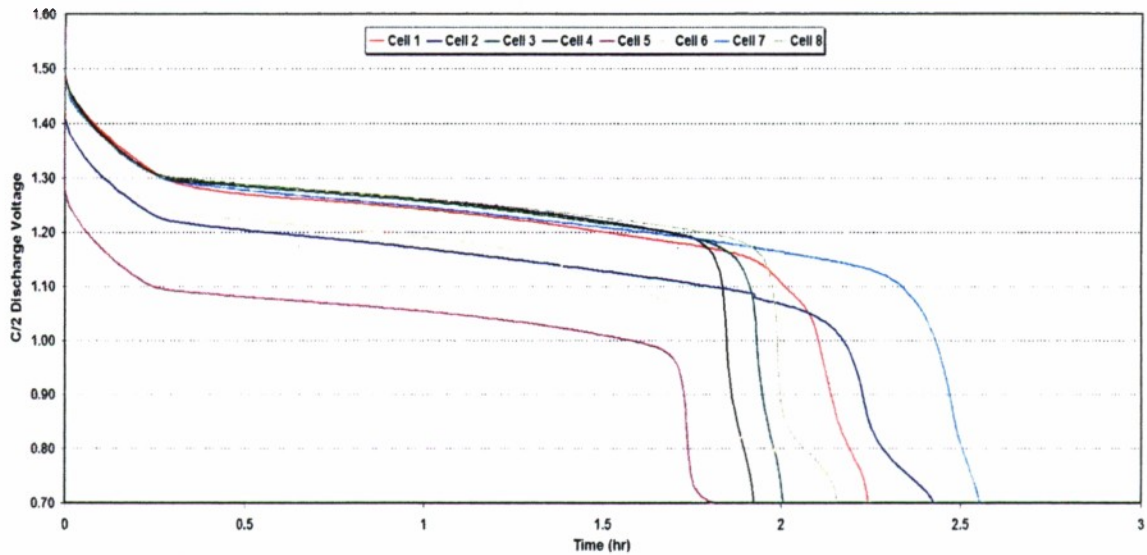
At the last post-reconditioning capacity check before cell 2 failed (cycle 643), the discharge and recharge voltage profiles are again plotted to determine how they had changed during the first 643 cycles. The results are shown in Figures 7 and 8. Figure 7 shows that significant discharge capacity was present in the form of a second plateau below 1 V for all cells. All the cells had significantly increased in capacity since the start of testing, with all except cells 2 and 5 attaining 76 Ah. Additionally, cells 2 and 6 had developed a decreased upper discharge voltage, which usually indicates resis-

Figure 7. Discharge voltage profiles at cycle 643 with a C/2 discharge rate.

tance from separator dry out. The drops in voltage for cells 2 and 6 at 1.5 to 2 h suggest that these cells may have intermittent shorting or impedance issues that could cause failure.

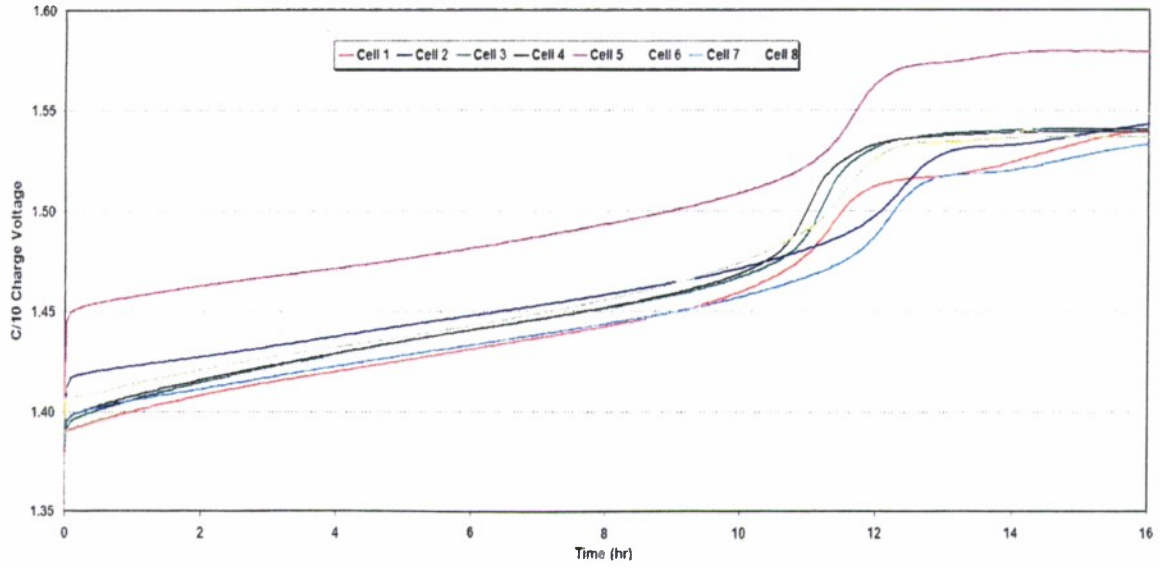
Figure 8. Recharge voltage profiles at cycle 643 with a C/10 charge rate.

Figure 8 suggests that all the cells either had hydrogen precharge or were close to the hydrogen pre-charged condition after 643 cycles.

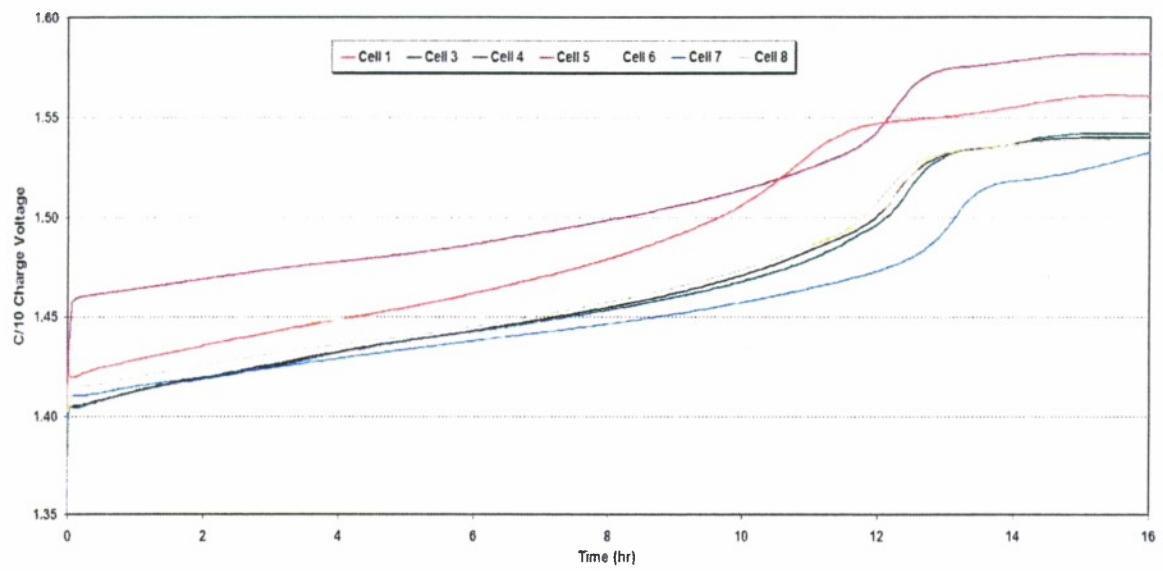
Figure 10 shows the charge voltage profiles for the cells after reconditioning at cycle 2020. Again, the discharge results shown in Figure 10 do not include cell 2 because it had failed. Figure 10 shows that all the cells that originally had nickel precharge have clearly developed a hydrogen precharge, as indicated by the sharp rise over 1.40 V and peaked voltage behavior at the start of the charge. The three remaining cells with higher concentration electrolyte (cells 1, 6, and 7) continue to display a pronounced secondary voltage rise after going into overcharge as γ -NiOOH is formed at the end of charge. Cycle 2020 was the last capacity check prior to the failure of cell 1. The recharge voltage for cell 1 only suggested that the capacity had degraded about 20%, and that the charge voltage had increased 10–20 mV, certainly not clear indications of imminent failure.

Figure 10. Recharge voltage profiles at cycle 2020 with a C/10 charge rate
